The Reconstruction and Failure Analysis of The Space Shuttle Columbia

Richard Russell¹, Brain Mayeaux¹, Steven McDanels², Robert Piascik³, Sandeep Shah⁴,
Greg Jerman⁴, Thomas Collins⁵, Warren Woodworth⁶

¹NASA JSC, ²NASA KSC, ³NASA LaRC, ⁴NASA MSFC, ⁵The Boeing Company,
⁶United Space Alliance

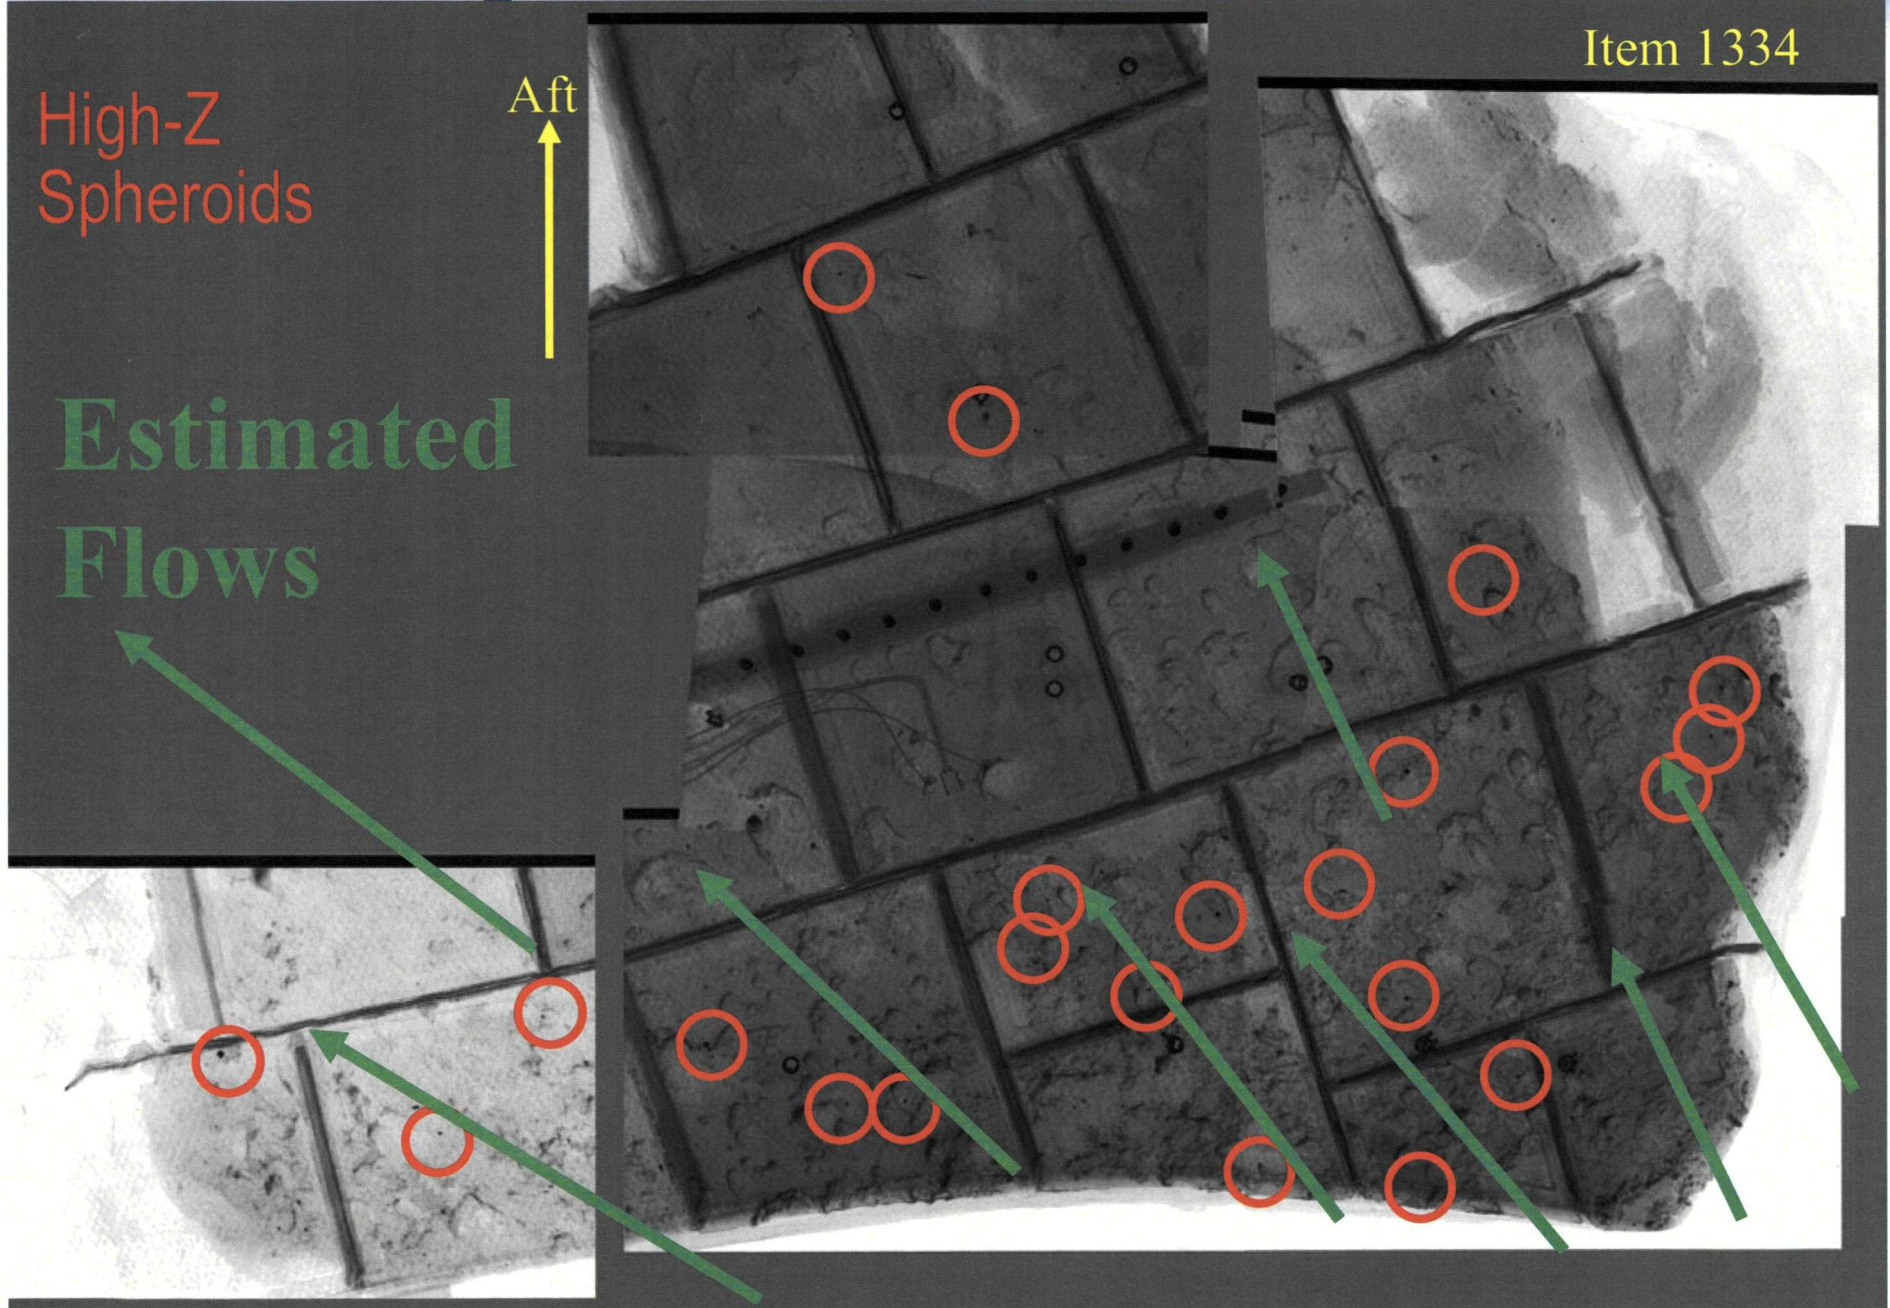
Corroborating Information – LH OMS Pod Analysis

High-Z
Spheroids

Estimated
Flows
